SHORT PROGRESS REPORT:

Effect of lactoferrin on osseointegration and bone healing around the dental implant : An experimental study in pigs.

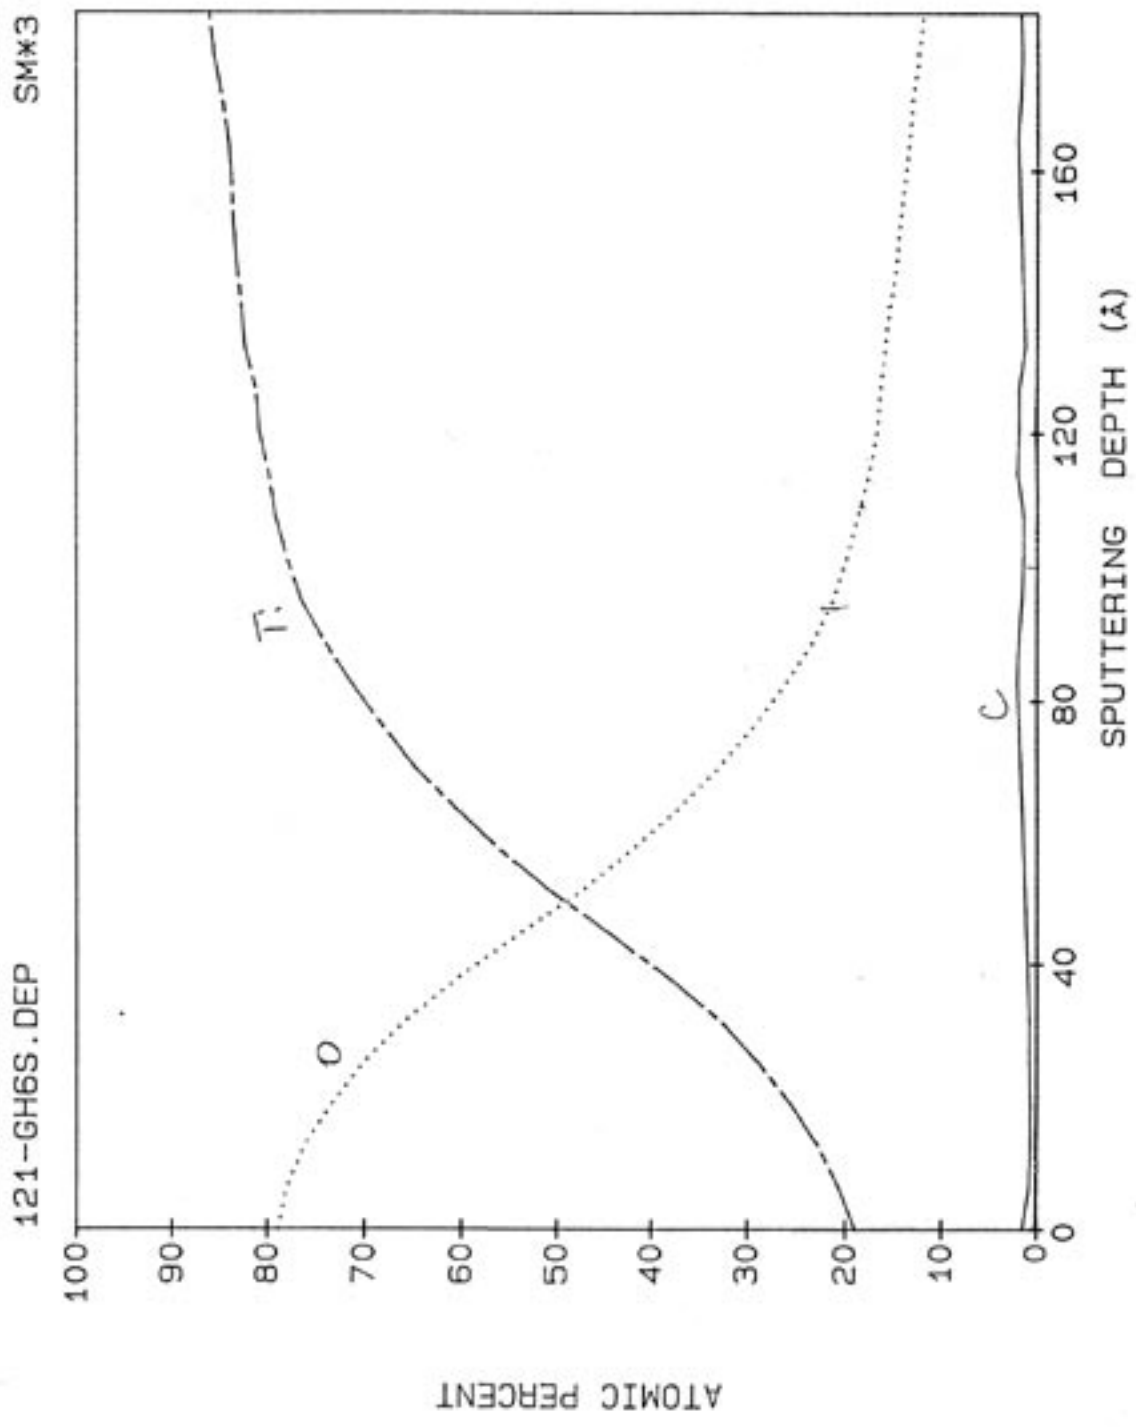
PEAK	SCALING FACTOR
C	1
CA	1
TI	1
O	1

3.75 X 7.7MM

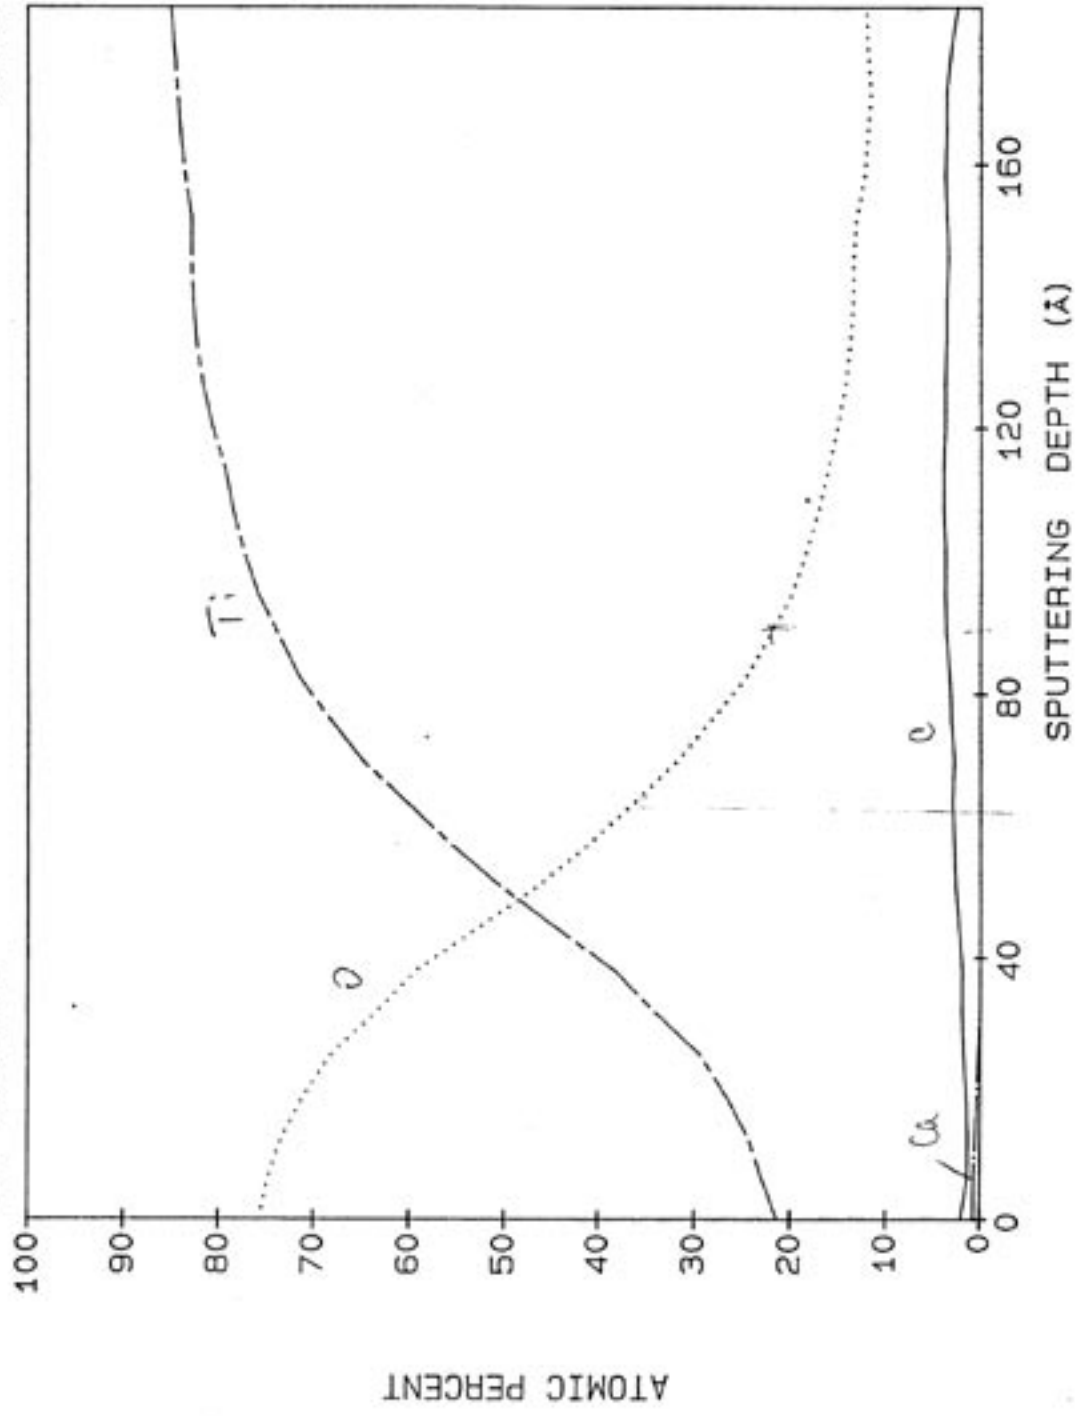
PEAK	SCALING FACTOR
C	1
CA	1
TI	1
O	1

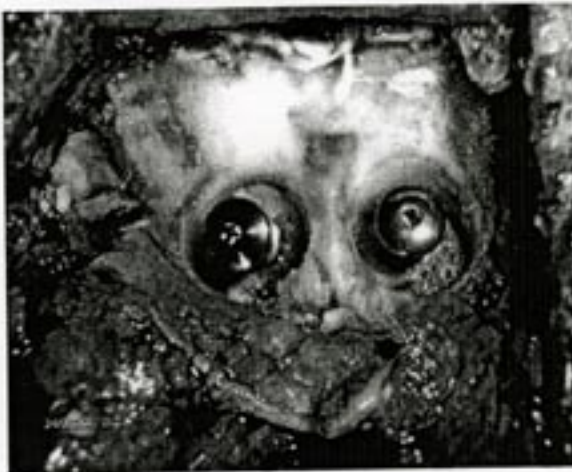
Figure 1 : Dental implants were placed into surgically created bone defects.

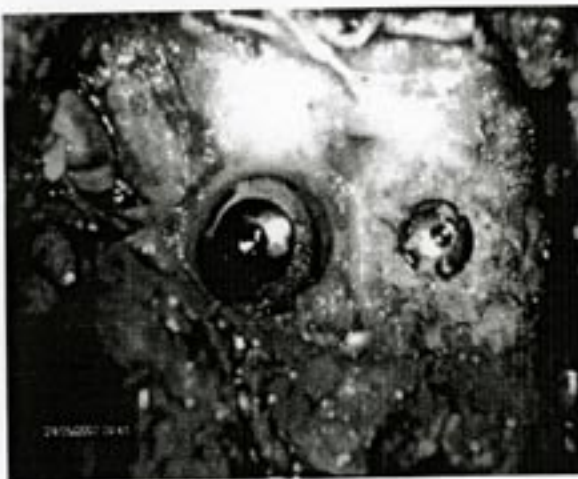
Figure 2 : The defect on the right side was filled with bovine bone hydroxiapatite

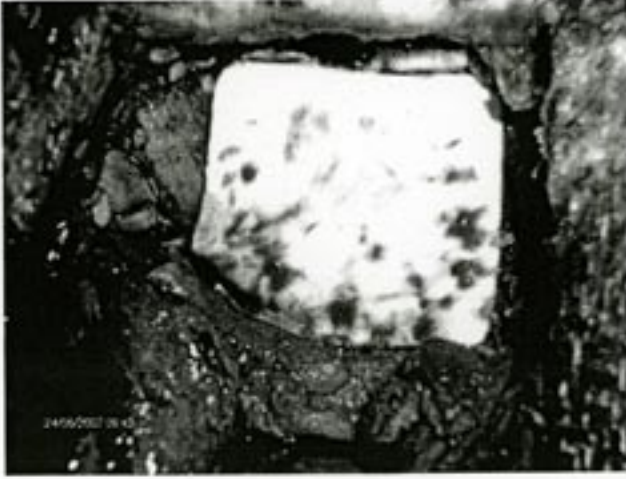
Figure 3: Each defect was covered with resorbable collagen membrane.
